Joint Action 2015 GPSD

Final Technical Report, Power Tools 2, Handheld electrical circular saws

Covering the period 20 April 2016 - 1 June 2018

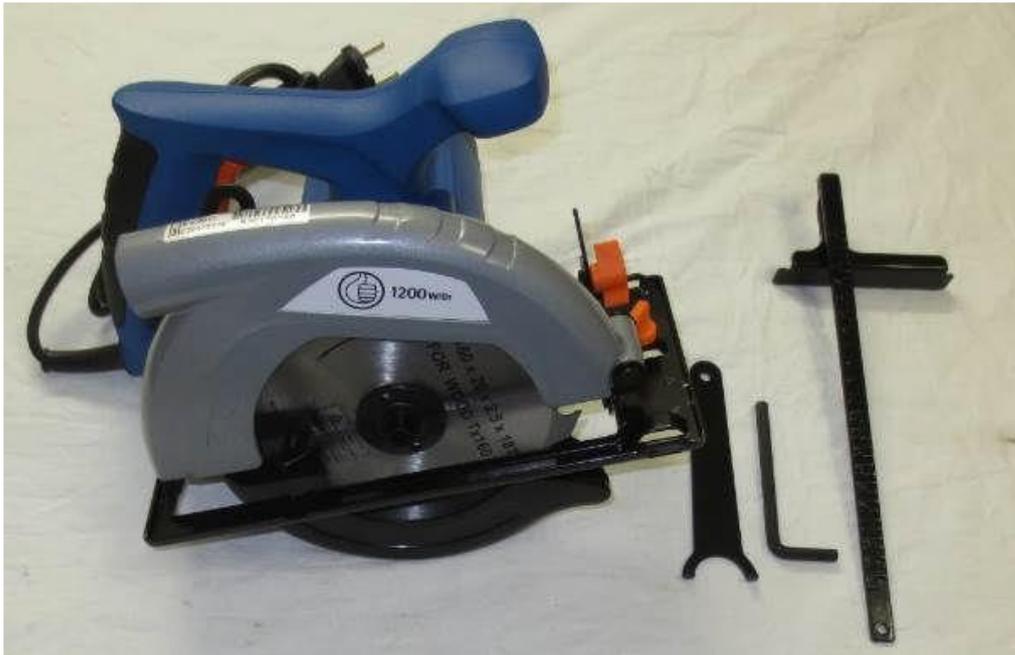
Figure 4: Example of a handheld electrical circular saw in the cheaper price classes with accessories.

Figure 3 shows the distribution of the samples over different price classes in intervals of 40 Euro. The two cheapest price classes appear to be the biggest with 36% and 29% share. Together they cover 2/3 of the samples. However, the more expensive classes, ranging up till more than 220 euro, are also represented. It is interesting to note the big number of less known brands available in the market (e.g. Figure 4).

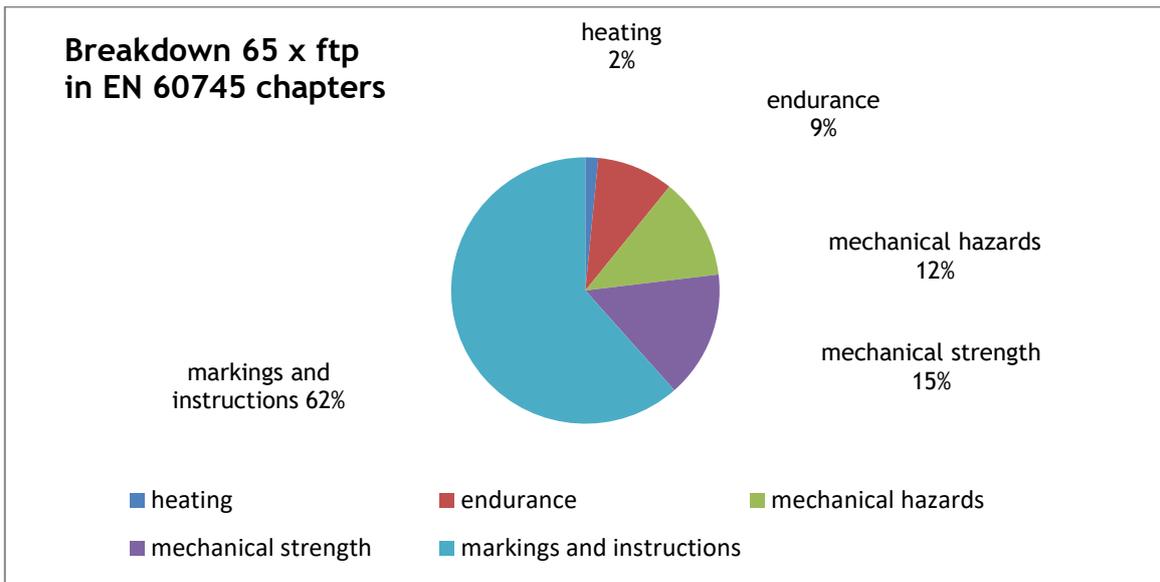
Figure 6: Overview of non-compliances identified in the 100 samples regarding safety requirements from EN 60745.

The joint test and examination programme identified non-conformities in 65 of the 100 sampled saws. This figure is broken down on the relevant clauses in the standard in Figure 6. The figure shows that errors in "markings and instructions" account for 62% of the non-conformities thereby being the most common cause. Samples presented multiple type of non-conformities at the same time.

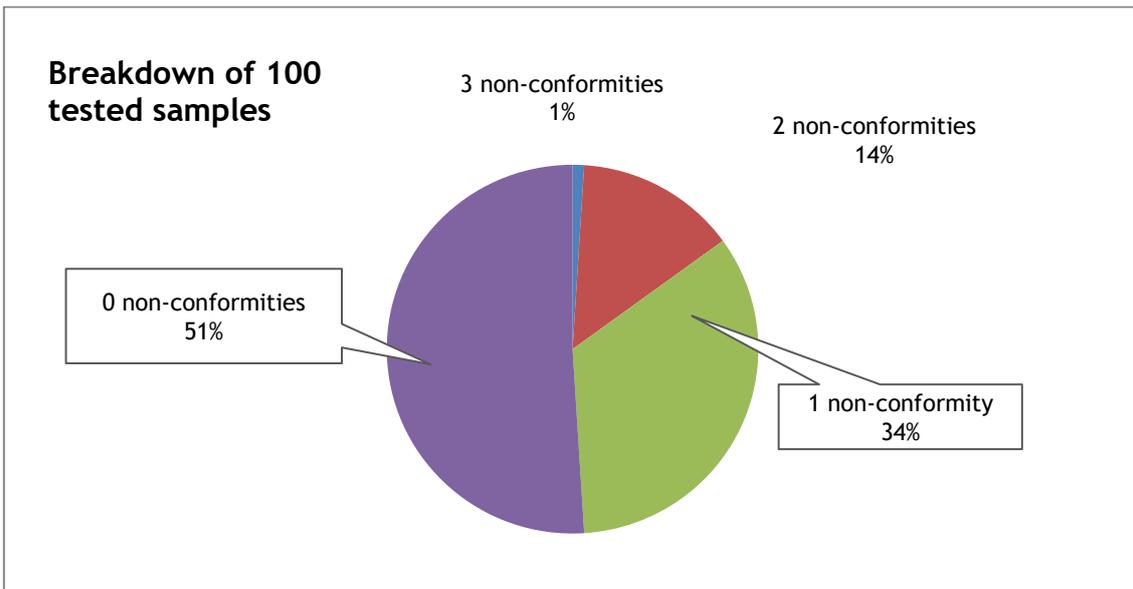
Figure 7: The share of saws that passed all tests, failed to comply with one clause, two clauses and three clauses.

Figure 7 below shows the number of failed clauses per sample.

Table 8 shows that the risks associated with the non-conformities that were found in the testing differ. These risk assessments are based on an analysis of one non-conformity. However, Figure 7 and Figure 8 showed that most of the tested saws had more than one non-conformity, so one would have to do a risk assessment for each of these. This would presumably lead to several risk levels. Risk levels do not add up as such and therefore the participants agreed on the principle of the "leading highest risk level" – the highest risk level determines the risk level for the product and thereby the "severity" that the MSAs shall apply in the enforcement activities. Apart from that, even the risk assessment of a single non-conformity may end up in several different risk levels if it is carried out by different people as can be seen in Table 8.

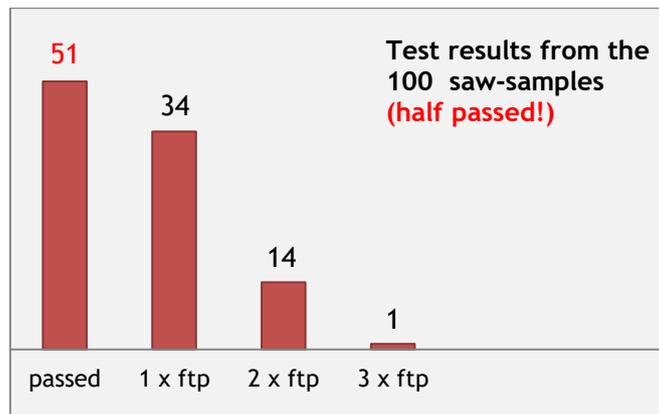
Figure 8: The number of samples that failed in one, two or three clauses in the standard.

Figure 8 below presents the same overview in a histogram - (ftp = "fail to pass").

A product may fail to meet several clauses, as can be seen in Figure 7 and 8. The table 5 also indicates whether a requirement is of administrative or technical nature.

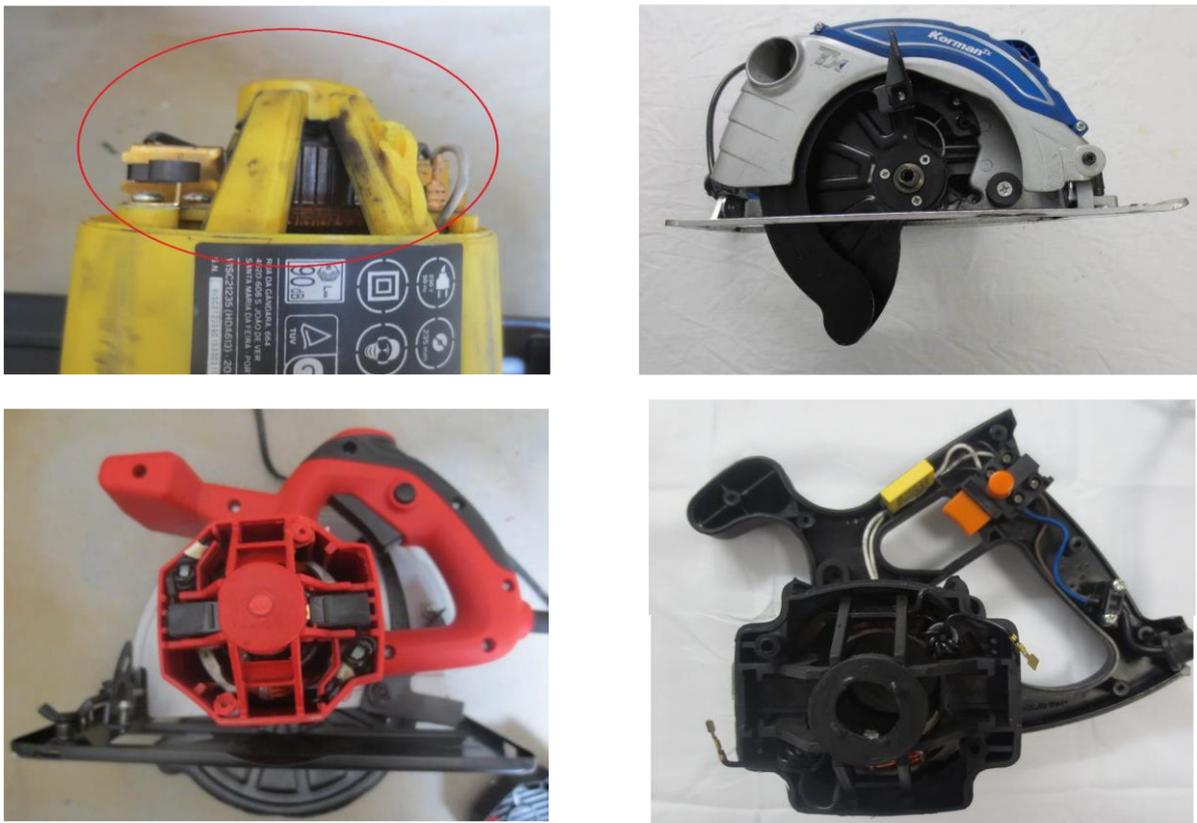
Figure 9: Different outcomes of the drop test (clause 20.3)

- *Top left photo* – The housing of the saw is damaged and part of the protection cap has broken off so the coal brushes and the commutator are exposed. Inside of the red circle in the photo, you can see where the brass coal brush holders (left) with a metal spring and the threaded metal electric connection clip (right) are. It means that the user can touch live parts and get an electrical shock. This situation is transferred into an injury scenario that yields "serious risk".

- *Top right photo* – The lower guard has been damaged in the drop test so closing is hindered and closing time has increased and become unpredictable. The question is whether a user will continue to use the saw after picking it up from the floor even though it has a dangerous and inadequately closing lower guard.

- *Bottom left photo* – The enclosure cap has broken off and live parts are accessible but not immediately touchable because the coal brush holders are not metallic and they are better protected in the housing. The sample did however fail the electric strength test afterwards. This outcome was assessed to present a medium risk to the consumer. Cases where the drop test resulted in cracks of the housing uncritical place(s) were assessed as a low risk.

- *Bottom right picture* gives a view inside the dismantled handle on a saw – The double-pole switch can be seen. A double-pole switch will completely disconnect the saw from the mains during the drop test because of the automatic release feature. This means that none of the electrical parts are live when the user picks up the saw after the fall and no risk remains. Unfortunately, most brands use single-pole switches.

The two cases posing a serious risk to consumer are both related to saws that fail in the drop test (clause 20.3). The housing broke, thereby exposing live parts.

The three high risk cases are either related to non-conformities in the endurance test (clause 19.101) or the drop test (clause 20.3). The samples that failed in the endurance test failed because the lower protection guarding failed during the 5.000 test cycles: the lower protection guard broke off or the spring operating the guard broke. The sample that failed the drop test failed because the lower protection guard was damaged. The three medium risk cases are related to non-conformities, such as insufficient upper guard covering of the blade cutting edge zone (clause 19.101) or complete lack of all safety warnings in the instruction manual.
