JOINT MARKET SURVEILLANCE ACTIONS 2016 ON PRODUCT SAFETY

FINAL REPORT ELECTRICAL APPLIANCES II (EA2): HAIRDRYERS, CURLING IRONS & HAIR STRAIGHTENERS

Joint Market Surveillance Action on Consumer
Products (JA2016)

October 2019

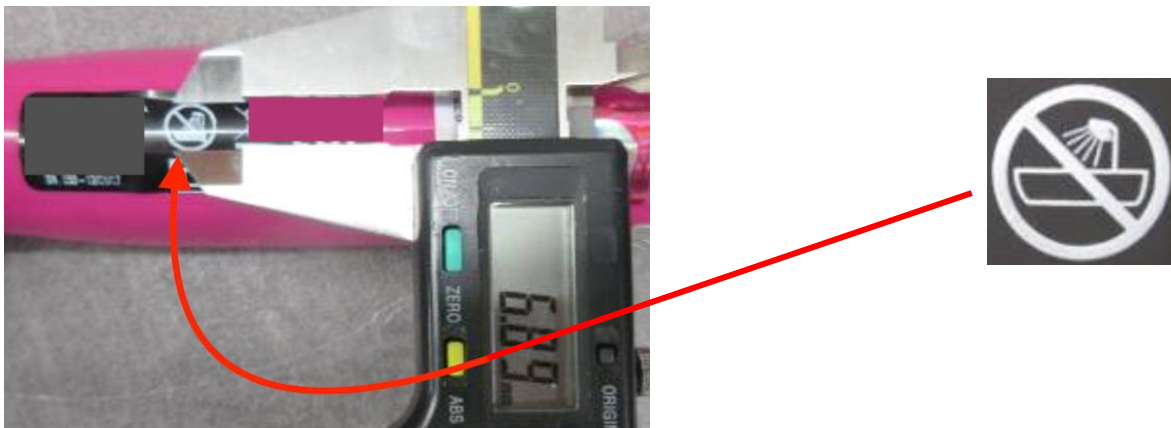
Figure 8 Undersized warning symbol

Hairdryers conforming to EN 60335-2-23 must be marked with a symbol warning against use of the appliance near water, as shown to the right in Figure 8. The diameter of the circle superimposed on the symbol must have a minimum diameter of 10 mm. In one case the diameter measured 6.89 mm, as shown to the left in Figure 8.

The absence of important safety information and warnings may not necessarily be considered as safety critical, but in certain circumstances it might give rise to a hazard. In each case, these markings and instructions non-conformities were deemed a low risk.

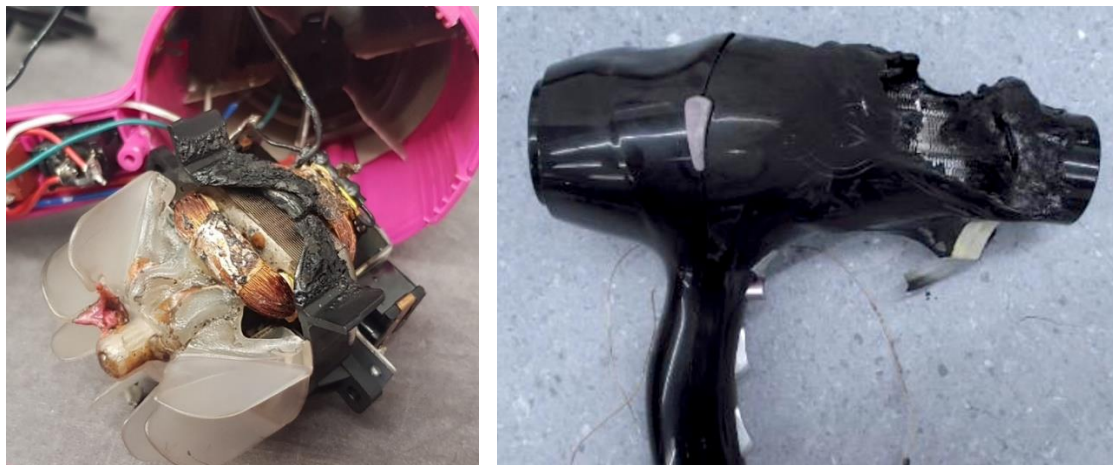
Figure 11 Motor winding overheating and no protection against stalled motor

The motor windings ignited in **5 of the 9** non-conforming samples. The extent of the overheating damage can be seen in Figure 11. Live parts were accessible after abnormal operation testing in **7 of the 9** non-conforming samples.

The image shown right in Figure 11 shows the extent of damage after the stalled motor test where live parts are accessible. Overall these non-conformities were deemed a serious risk.

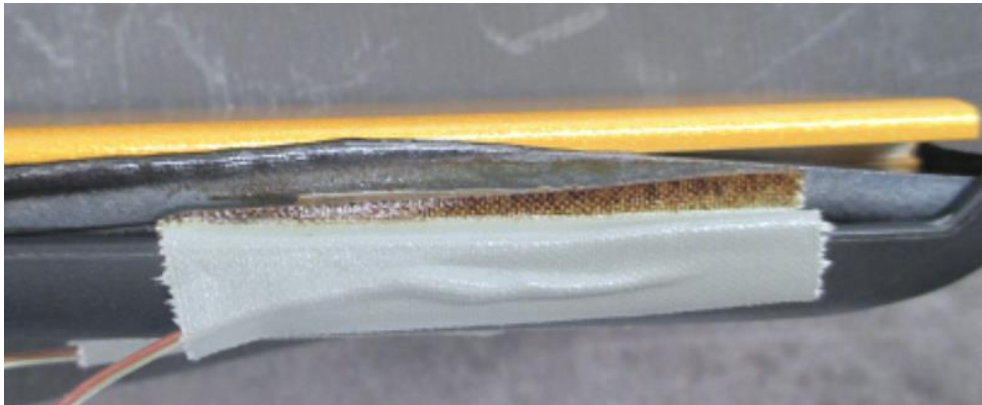
Figure 14 Enclosure deformation after abnormal operation test

Abnormal operation failures were recorded for 3 of the 23 non-conforming hair straightener samples. In one sample, the plastic enclosure melted before the operation of the thermal cut-out, which is intended to prevent such overheating damage. In another sample the temperature control device was subjected to a short-circuit (which is an allowable fault condition). The sample reached temperatures of almost 300°C, and the extent of the enclosure deformation can be seen in Figure 14.
